Technical Bulletin #4

Study of the Effect of
Fitch Fuel Catalyst on Microbial Contaminated Diesel Fuel

TREATMENT OF BIO CONTAMINATED DIESEL FUEL WITH METAL ALLOY FUEL CATALYST

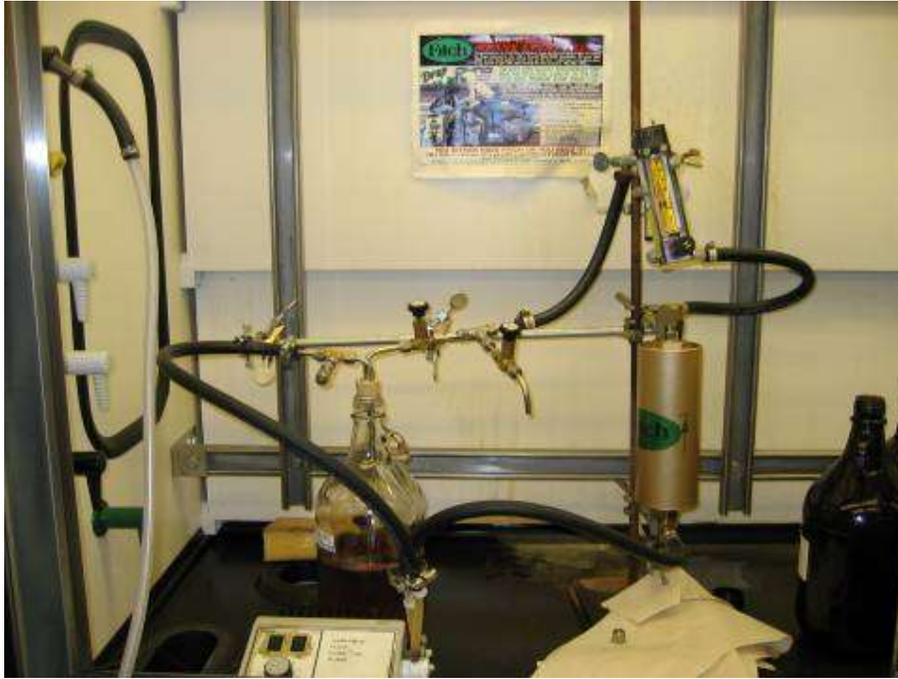
A re-circulating system designed to simulate a diesel engine fuel system was constructed consisting of a fuel reservoir (tank), a variable rate fuel pump, an In Line catalyst system, a flow meter, and draw off taps for removal of fluid samples. The specific In Line catalyst system employed for this analysis was a Fitch Fuel Catalyst - Model F 750 catalyst formula C supplied by Advanced Power Systems

The treatment or exposure of contaminated spoiled diesel to the Fuel Catalyst was performed by incorporating the In Line FFC device into a re circulating system shown in Figure 1.

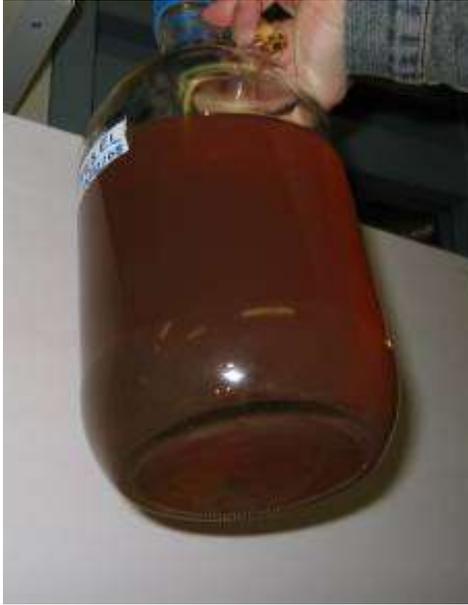
Figure 2. Microbial spoiled diesel #2

The spoiled diesel # 2 was very dirty and turbid. The Figures 2 and 3 show the appearance of the spoiled diesel after the 2-month incubation period before initiation of exposure to the fuel catalyst. The treated diesel appeared as in Figures 4 and 5

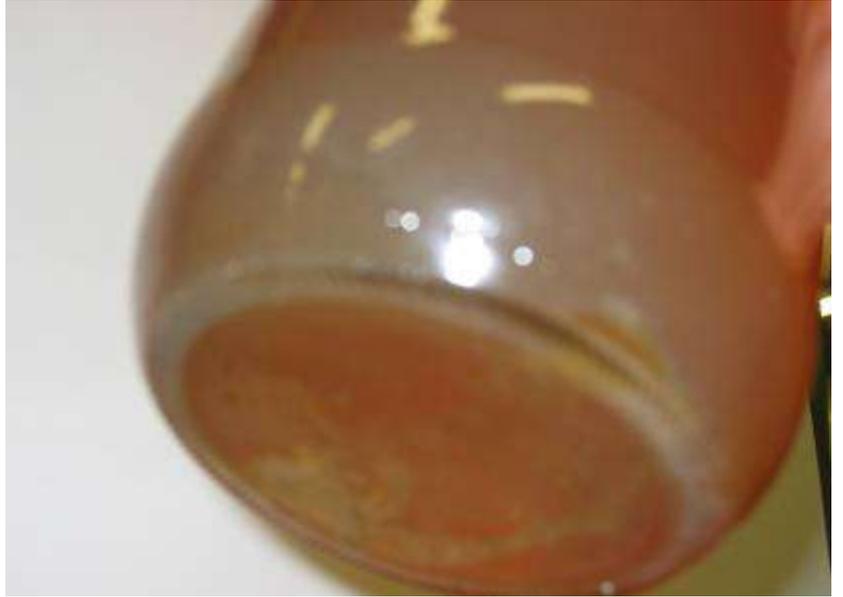
Figure 3. Close view of the microbial spoiled diesel

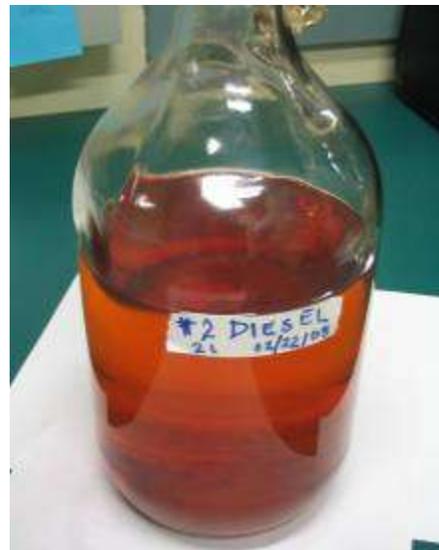
Figure 5. Microbial spoiled diesel DF2 after treatment

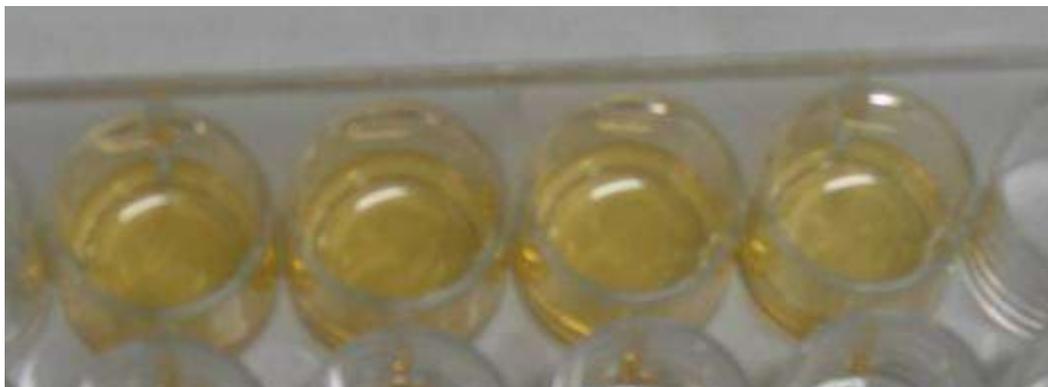
Figures 6(top) and 7(bottom). Color variation in diesel fuel after undergoing continuous treatment in the fuel circulatory system with the In Line FFC device. Figure 6 is taken with extra lighting, figure 7 is with normal room lighting. The numbers denote the hours of exposure, after which the diesel was drawn for analysis.

The color of the diesel changed gradually in direct proportion to hours of treatment. Figures 6 and 7 show the color variation. The left most shows the color at the beginning of treatment while the right most shows at the end of treatment.
