Evaluation of the Fitch F500 Fuel Catalyst for use in marine diesel engines

Background

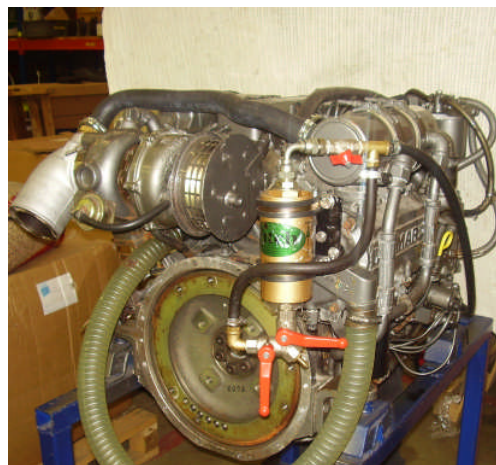
Figure 1 Yanmar 4LHA Engine used for the fuel catalyst test

The test was applied to a Yanmar 4LHA engine which had been used for a military evaluation engine prior to the test.

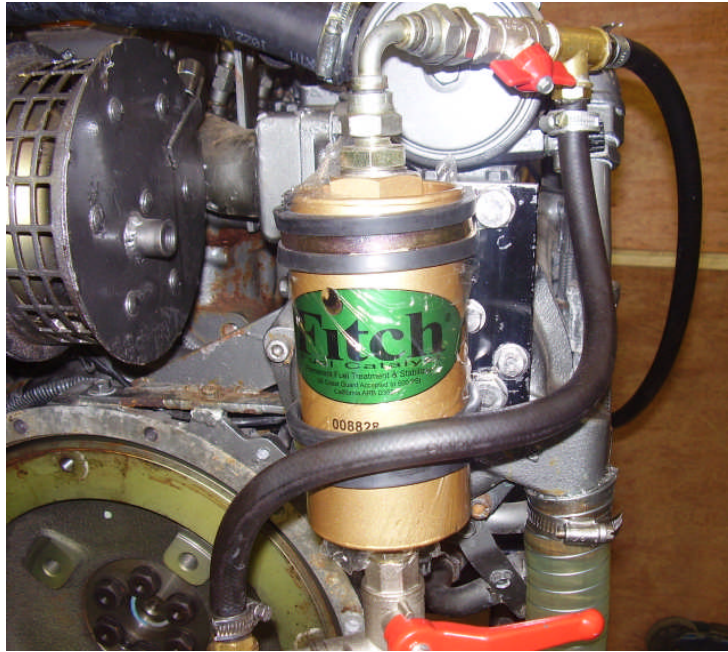
Figure 2 Fitch F500 Fuel Catalyst

“The Fitch Fuel Catalyst is a polymetallic alloy housed in a canister and connected into an engines fuel system between the fuel tank and the engine after the fuel filter and before the fuel pump. Its purpose is to reformulate fuel on board the vehicle prior to combustion. It performs its function at the temperatures experienced by vehicles in normal service. The Fitch Fuel Catalyst is not a fuel additive. It is a special alloy that does not dissolve in fuel. The fuel is reformulated by the alloy catalyst to a state where it is capable of a more complete combustion. As a result, an engine converts the chemical energy in the fuel to mechanical energy in a more efficient manner. The engine power is increased as a result and the toxic exhaust emissions are decreased.” The US Armed Forces have certified the Fitch as MIL F901D compliant for use in battlefield conditions. We have also seen copies of ASTM standard tests conducted on behalf of the US Department of Defence to confirm the Fitch Unit’s ability to arrest fuel algae and the problems caused by it.

The Fitch catalyst was then fitted inline into the fuel system prior to the fuel injection pump. A test run was then carried out taking measurements at two
